X-raying Pandora's box

If you can't see your chainplates, there's only one way to inspect them

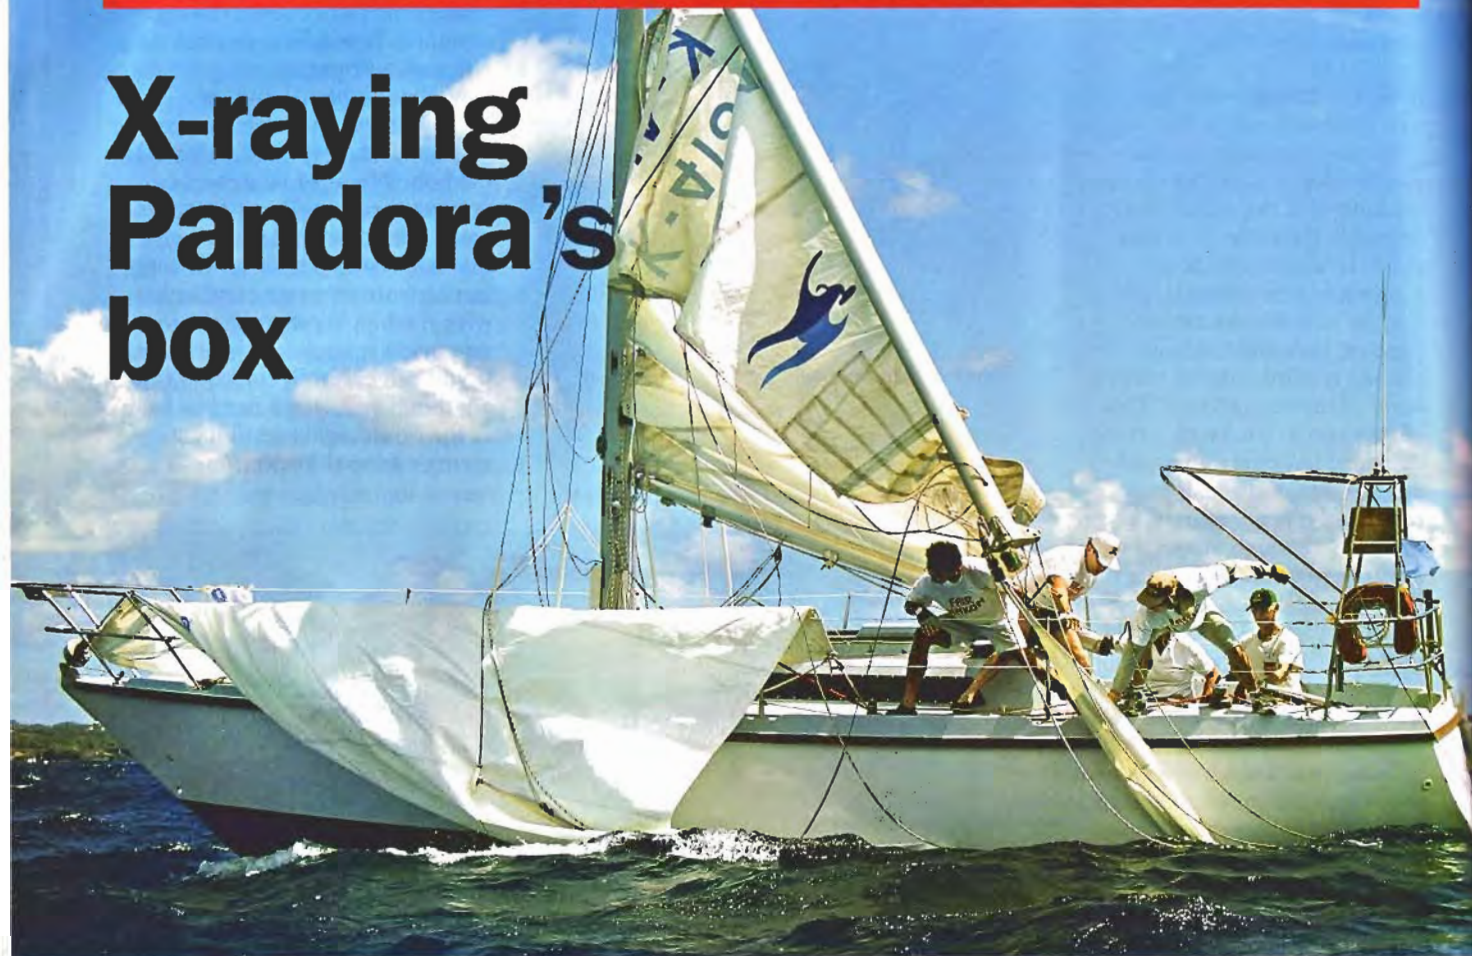
It's coming down. Faulty chainplates, corroded inside the hull, can bring down your rig if not properly inspected.

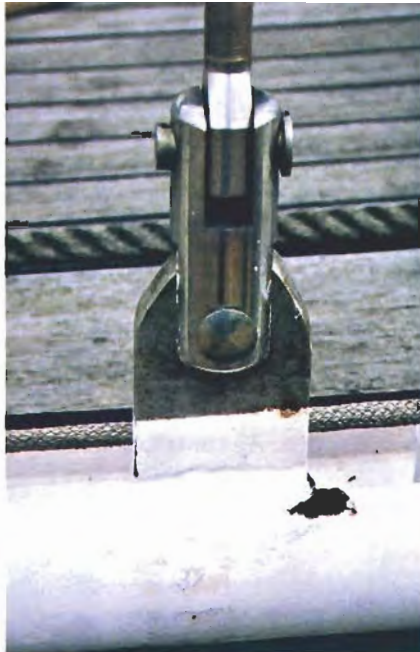
Just because the top half of the chainplate shines doesn't mean it's sound (top, left). The part fiberglassed below the caprail is what we're worried about.

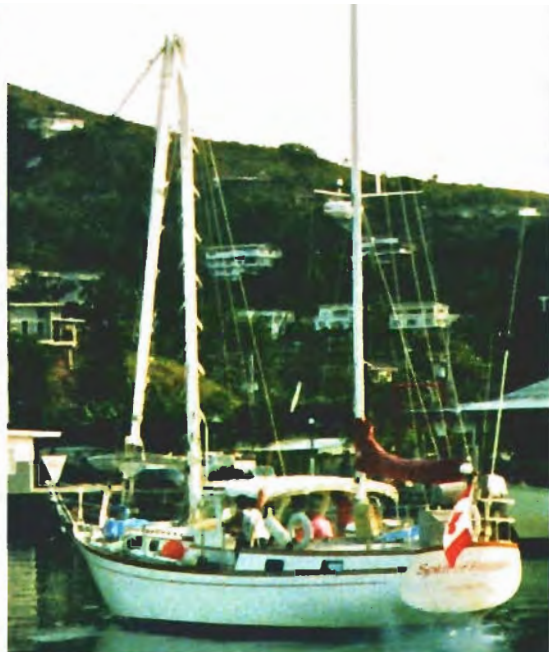
Three men, three hours, eight chainplates to inspect. *Elizabeth Ann* ready to be x-rayed (top, right).

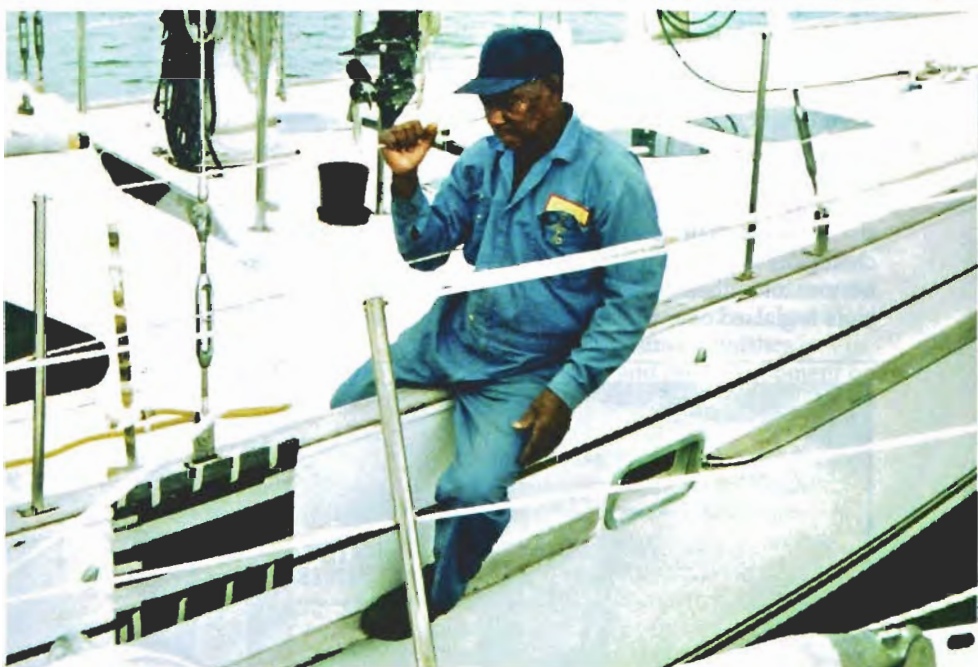
A technician tapes a piece of 14" x 17" film to the hull before moving 30-feet away for safety (middle).
