STANCHION INSTALLATION

Repair and bedding of Irwin stanchions

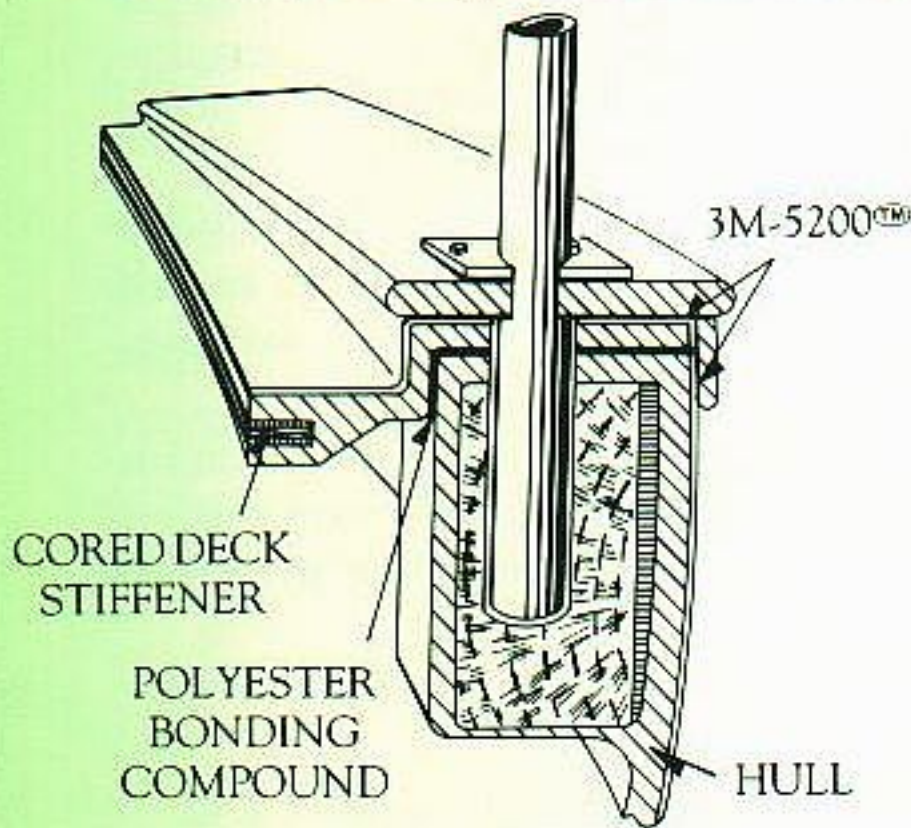
An ash block is laminated and sealed under the hull-to-deck flange during hull lamination. After the deck is installed, a hole is

drilled through the deck and hull flange into the block, the hole is resin sealed and the double course stanchion is installed in 3M-5200TM adhesive.

The screws in the base strap hold the stanchion down in the socket. The result is a system that relies on the

strength of the stanchion post instead of attachment to the yacht.
